Our reference
V-USA-1-0-10

Subject: VELUX® SKYLIGHT REPLACEMENT CLADDING PARTS

Skylight Deck Mount Models – Pictorial

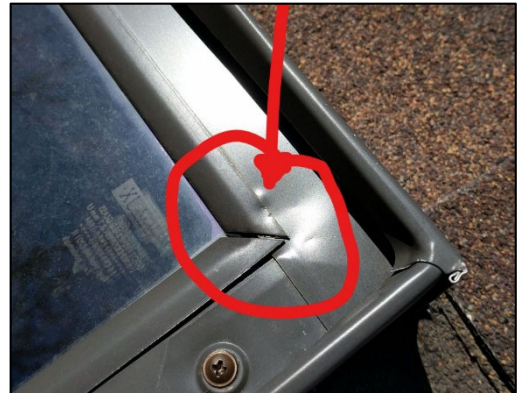
Hailstorms occur frequently throughout the United States where VELUX® residential skylights are installed. The most frequent damage experienced by VELUX skylights during hailstorms is damage to the aluminum cladding covers from hailstone impacts. Larger hailstones can result in unseen damages to the primary weatherseal securing the glass to the aluminum cladding. Therefore, replace the entire skylight anytime the skylight has been damaged by hailstones larger than 2" in diameter. Anytime there is hail damage to the cladding sealed directly to the skylight glazing (glazing profile), replace the skylight as the primary weatherseal is likely compromised. See photo at right for hail damage to glazing profile. This primary weatherseal is an adhesive sealant applied in the factory which cannot be repaired or re-applied in the field. Replace the existing flashing anytime a new skylight is installed or whenever the roof is replaced around an existing skylight. Reusing existing flashings requires the flashing components to be removed resulting in nail holes throughout the flashing and reinstalled without the use of proper installation instructions. Reusing existing flashing often results in future roof leaks around the flashing. VELUX offers the below guidance when servicing cosmetic damage to VELUX skylight cladding after a hail event.

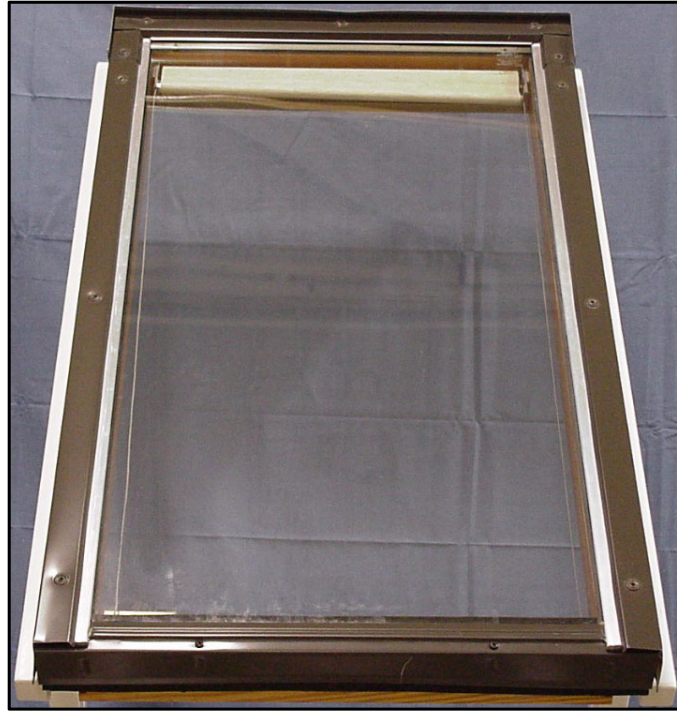
FS M82 / FS M85 / FS M87**Mfg 12/1982 – 03/1995**

No replacement cladding parts.
Skylight replacement only.
Distinguished by exterior screws
through the top of the cladding
covers

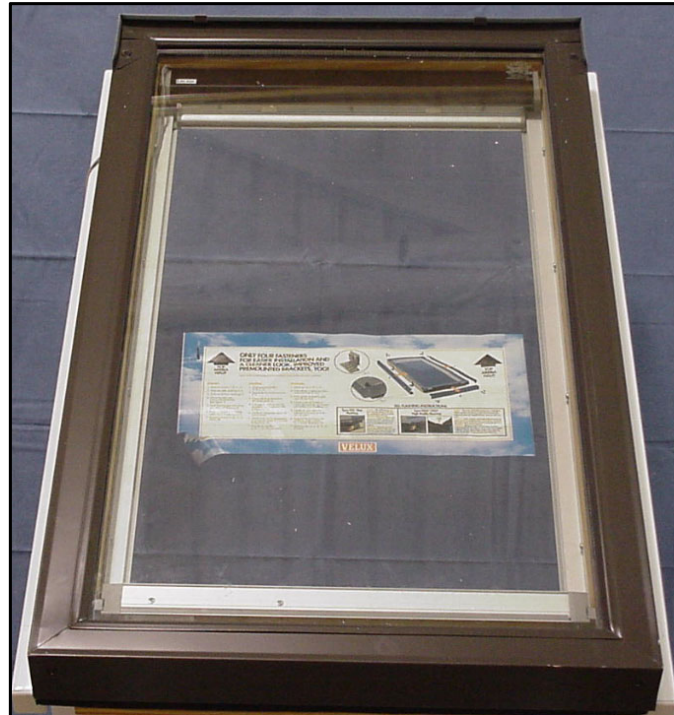
**FS M95****Mfg 04/1995 – 05/2004**

No replacement cladding parts.
Skylight replacement only.

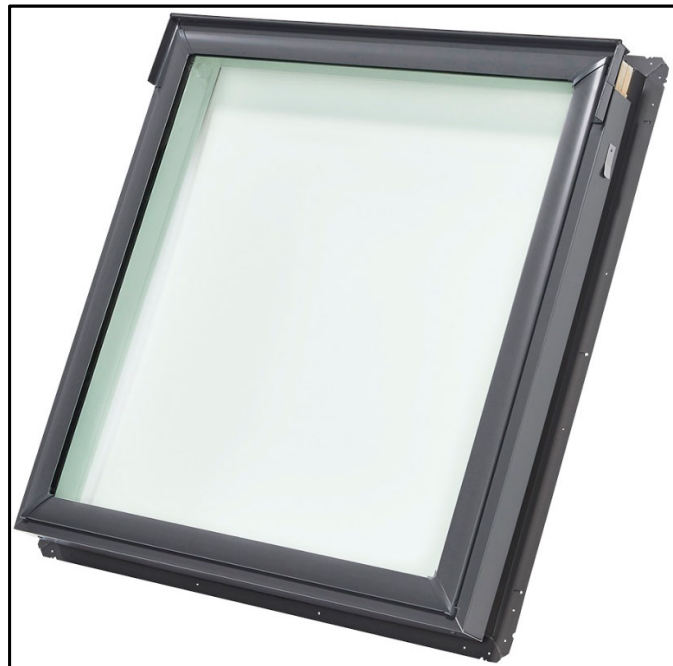
**FS A21****Mfg 01/2010 – Present**Replacement cladding parts only
for frame cladding covers,
otherwise complete skylight
replacement.Distinguishing features are
rounded glazing profile cladding
and light grey color.

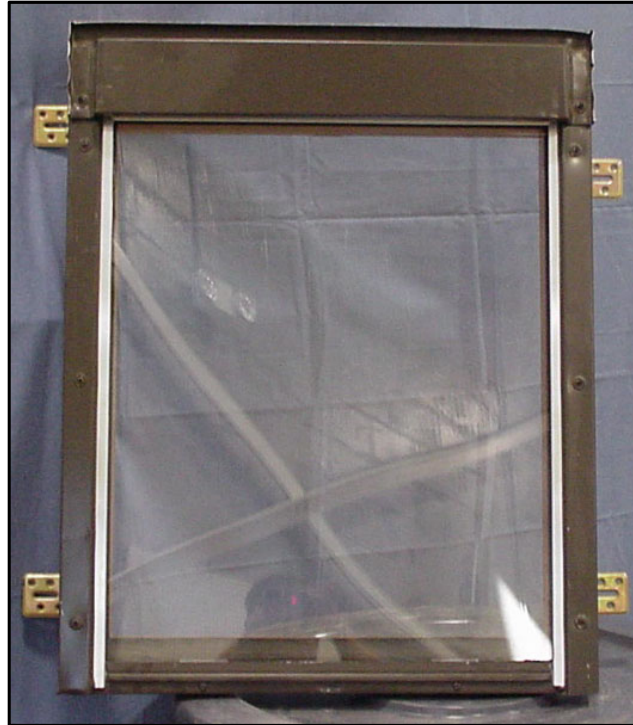
FSF M87**Mfg 03/1987 – 02/1995**

No replacement cladding parts.
Skylight replacement only with
fixed or venting skylight.
Distinguished by exterior screws
through the top of the cladding
covers

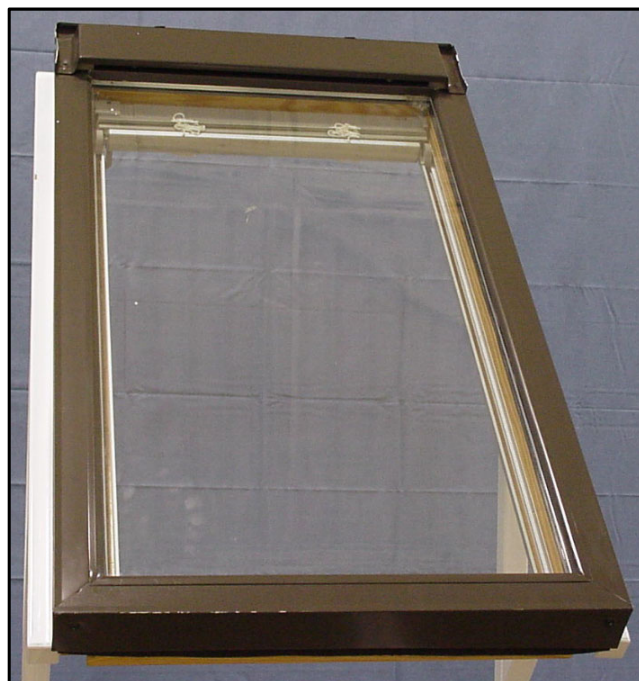
**FSF M95****Mfg 03/1995 – 07/2007**

Replacement cladding parts
available.

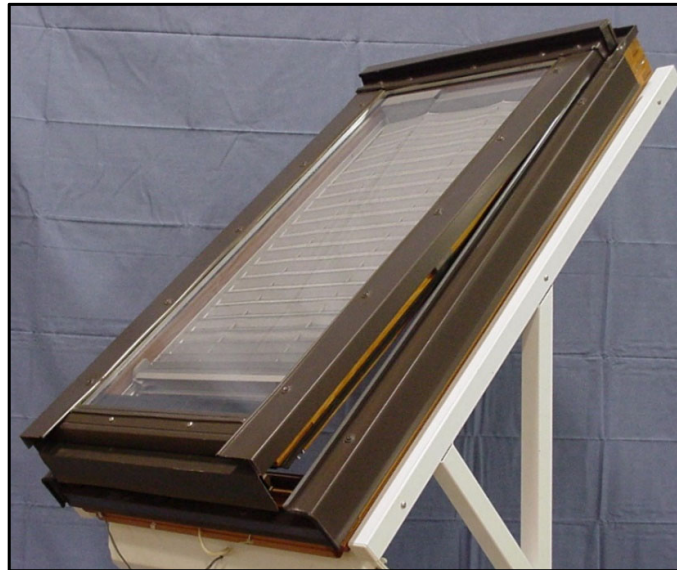
**VS M84 / VS M87 / VSC
Mfg 02/1983 – 01/1996**

No replacement cladding parts.
Skylight replacement only.
Distinguished by exterior screws
through the top of the cladding
covers

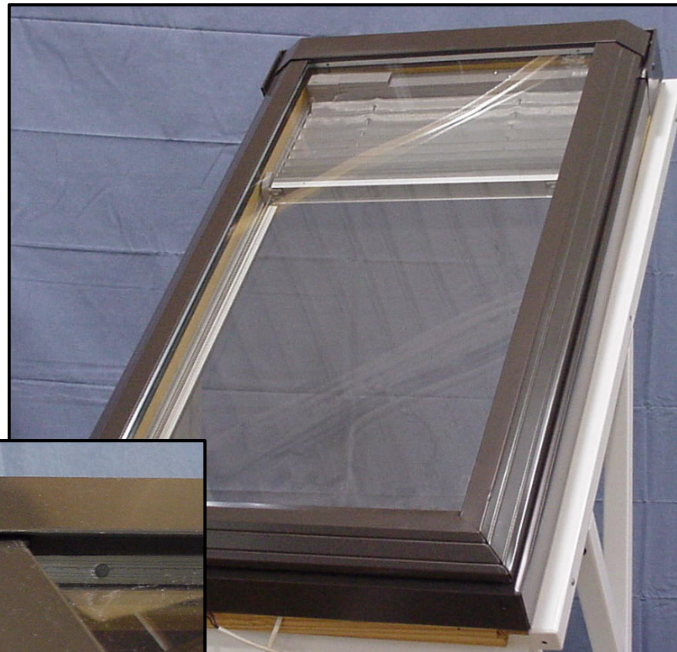
**VS M96 / VS M96B
Mfg 02/1996 – 02/1998**

No replacement cladding parts.
Skylight replacement only.
Distinguished by no exterior
screws in the side and bottom
claddings and shape of top
cladding cover.

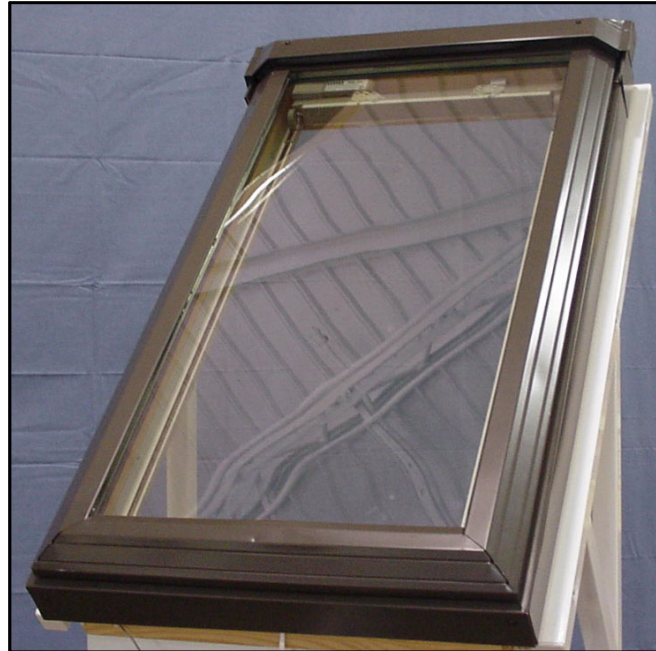
**VS M98 / VS M01 / VS M03
Mfg 04/1998 – 04/2004**

No replacement cladding parts.
Skylight replacement only.

VSE M01**Mfg 02/2000 – 04/2004**

Distinguished by shape of top
cladding cover.

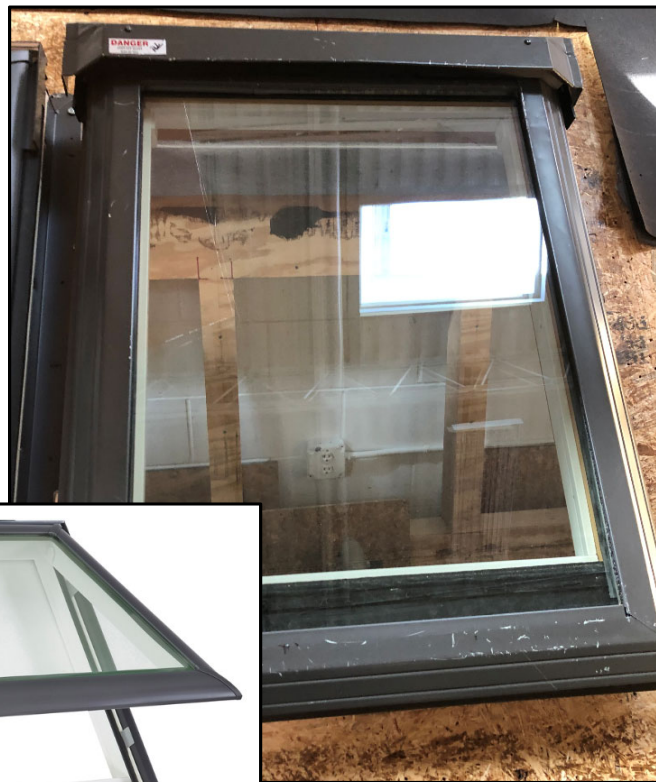
**VS / VSE H04****Mfg 05/2004 – 12/2009****VS / VSE / VSS A21****Mfg 01/2010 – Present**

Frame cladding parts available.
Sash complete required if sash
cladding damaged.

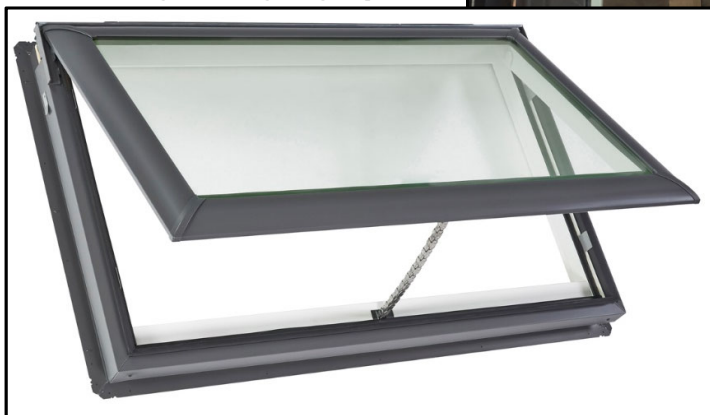
**A21 with rounded sash
cladding and light grey color**
